Manhole Inspection Summary

Manhole # S43QQ_005MH

Insp Date: **4/2/07 12:46 PM**

Location Address: **2526 HARFORD RD**

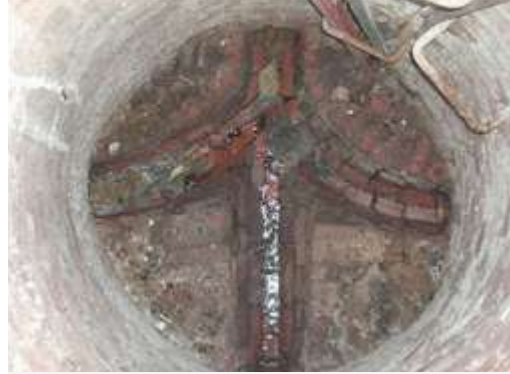
Top View

Corroded steps. Evidence of surcharge - Bench debris. Channel debris.

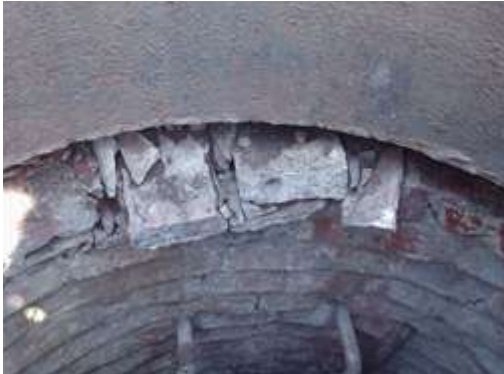
Defect

Frame Offset: **1** (in.) Condition: ☐ Sound ☐ Cracked ☒ **Leaks**

Condition: ☐ Sound ☐ Cracked ☐ Root Intrusion ☒ **Loose Brick** ☒ **Deteriorated**

Frame leaks. Frame offset. Adjustment deterioration, loose brick and infiltration. Corbel deterioration and infiltration.

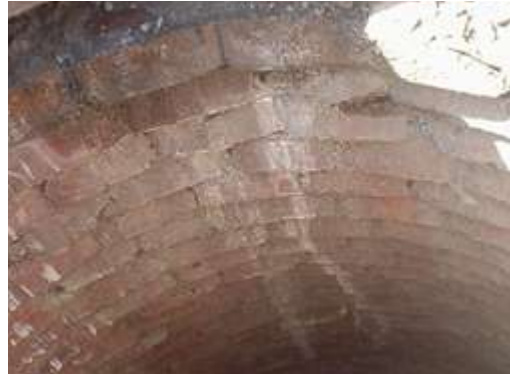
Defect

Condition: ☐ Sound ☐ Cracked ☐ Root Intrusion ☐ Loose Brick ☒ **Deteriorated**

Adjustment and Corbel deterioration and infiltration.

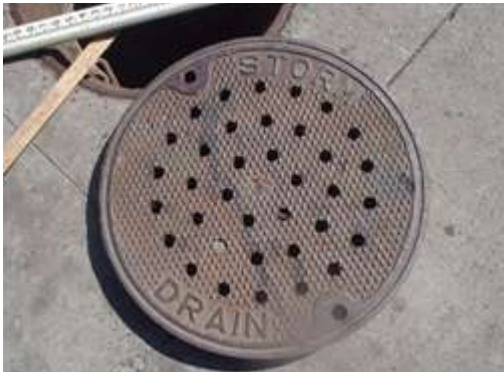
Defect

Storm drain cover.

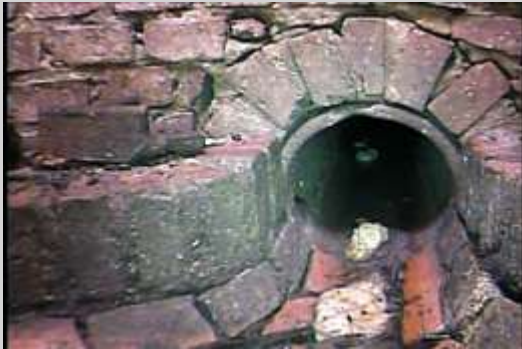
8 in. Circular Gravity Sewer Pipe Out @ 12 O'Clock

Barrel deterioration and infiltration. Channel deterioration.

Infiltration: **None** Pipe Seal Cond: **Broken**

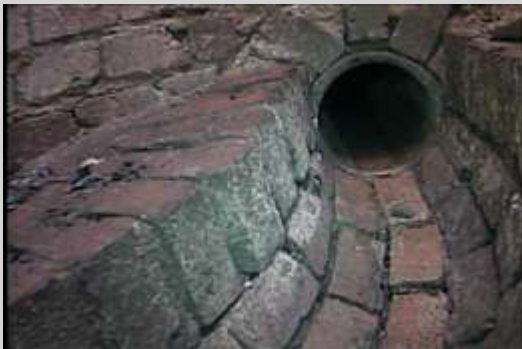
8 in. Circular Gravity Sewer Pipe In @ 3 O'Clock

Channel deterioration. Bench deterioration.

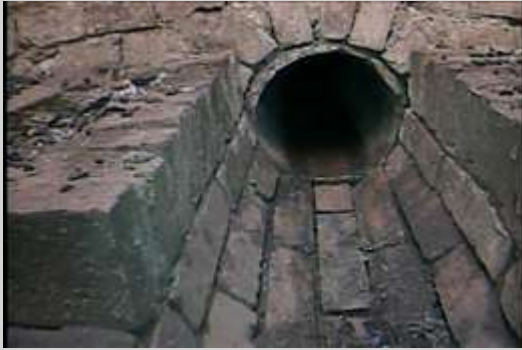
Pipe In @ 6 O'Clock

Barrel infiltration and deterioration. Channel deterioration.

Infiltration: **Evidence** Pipe Seal Cond: **Broken**

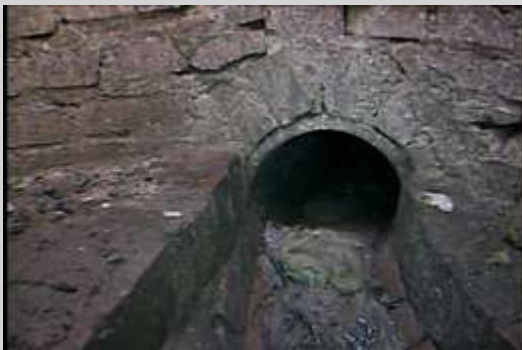
Pipe In @ 9 O'Clock

Barrel deterioration and infiltration.
